Myometrial Insertion of Essure® Mirco-Insert

Jeffrey J Woo^{1*}, Barbara E Simpson¹, Dale W Stovall²

¹Department of Obstetrics and Gynecology, Riverside Regional Medical Center, Virginia, USA

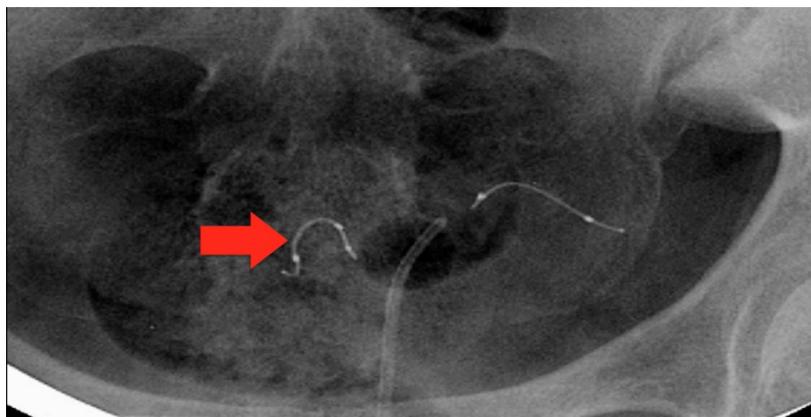
Four months after the procedure, the patient had a routine confirmation HSG. Assessment of the HSG revealed that the left micro-insert appeared to be properly placed in the left fallopian tube (Figure 1). In contrast, the right micro-insert had an acute curvilinear appearance (Figure 1). As dye was injected, free spill was evident from the right side but the origin was unknown (Figure 2). The radiologist report stated the right fallopian tube was not occluded and the right micro-insert was not contained within the right fallopian tube. The patient was scheduled for counseling in regards to further assessment and management with presumption of a cornual or fallopian tube perforation.

Figure 1. HSG image displaying an acute curvilinear appearance of right micro-insert.

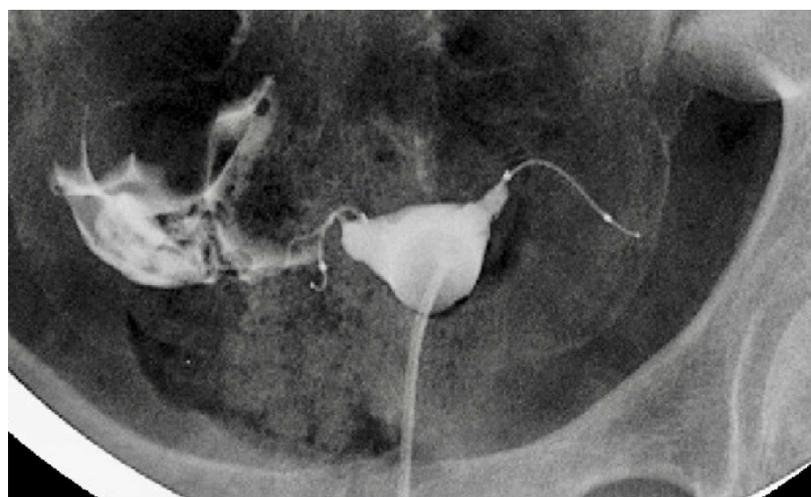
Figure 2. HSG image displaying free-spill from right side with injection of dye.

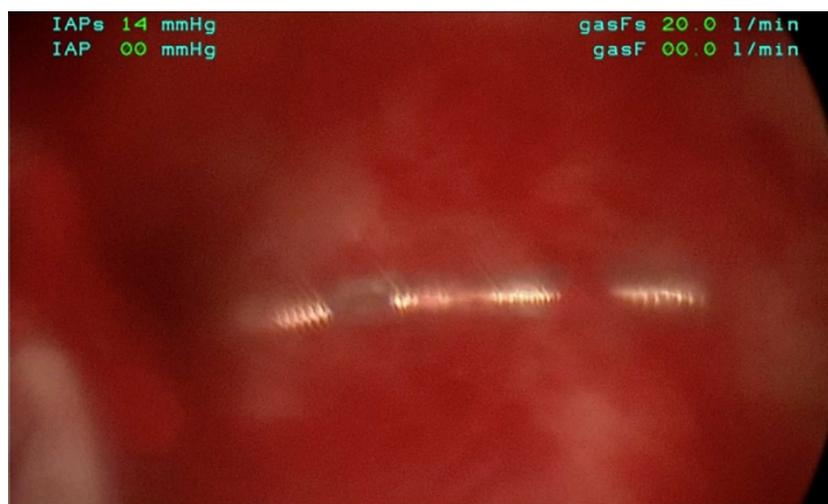
On the day of her procedure, initial hysteroscopic evaluation revealed 30-40 trailing coils extending from the right tubal ostia (Figure 3). This was in contrast to the 3 to 4 trailing coils appreciated after the initial insertion. The left tubal ostia was clearly visualized with no micro-insert coils identified in the intrauterine cavity. Due to the length of the right-sided micro-insert present within the uterine cavity, attempts were made to release and retrieve the micro-insert using hysteroscopic operative forceps. Resistance was appreciated and several attempts to retrieve the micro-insert only expanded the coils without release of the device.

Figure 3. Thirty to forty trailing micro-insert coils visualized in uterine cavity during hysteroscopic evaluation.

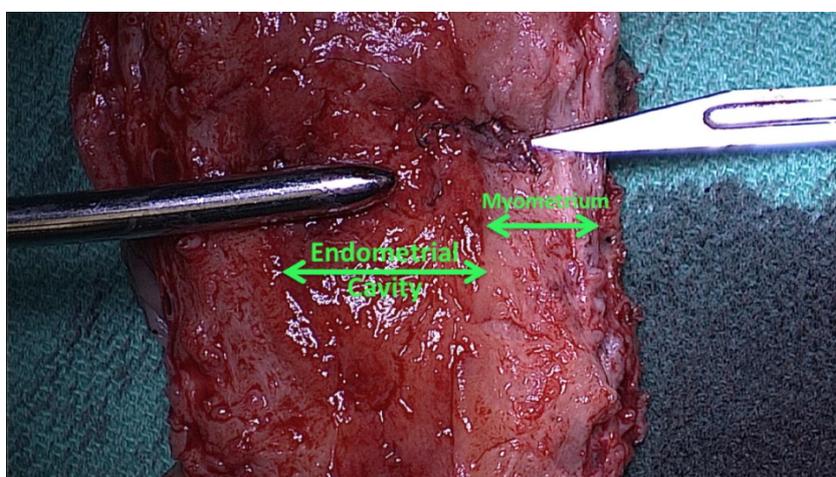
Figure 4. Midline coronal dissection displaying the micro-insert penetrating into the myometrium.

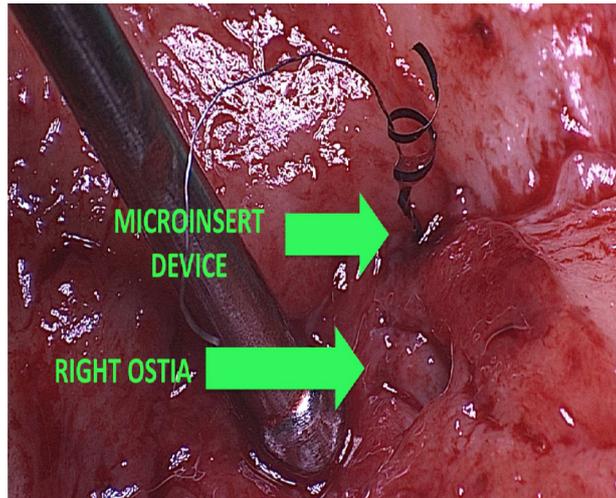
Figure 5. Micro-insert penetrating superior to right tubal ostia.

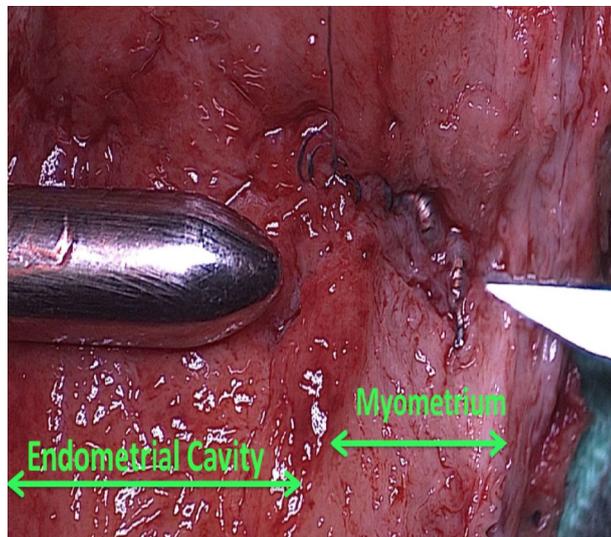
The uterine specimen was removed and thoroughly examined. Grossly, as noted by diagnostic laparoscopy, there was no evidence of perforation of the uterine serosa by either micro-insert. The uterine specimen was dissected in a midline coronal manner superiorly from the cervix to the fundus and the device was found inserted superior to the right tubal ostia (Figures 4 and 5). On further dissection, it was discovered that the device was firmly embedded through more than half of the myometrium (Figure 6).

Figure 6. Micro-insert embedded into uterine myometrium without penetration through the uterine serosa.

The expulsion of 30-40 coils visualized in the uterine cavity 4 months after insertion on the right side may be explained by recoil from a dense, non-compliant myometrial tissue. Unlike the compliant fallopian tube lumen, the myometrium's dense non-compliant tissue likely rejected the device causing an initial post-procedure partial expulsion and then a later fibroblastic inflammatory response resulting in myometrial embedding (Figure 6).
