Avascular necrosis of vertebral body with fracture of unilateral posterior facet at the level of insertion of interspinous device.

Kook Jin Chung*, Ik Yang

Kangnam Sacred Heart Hospital, College of Medicine, Hallym University, Korea

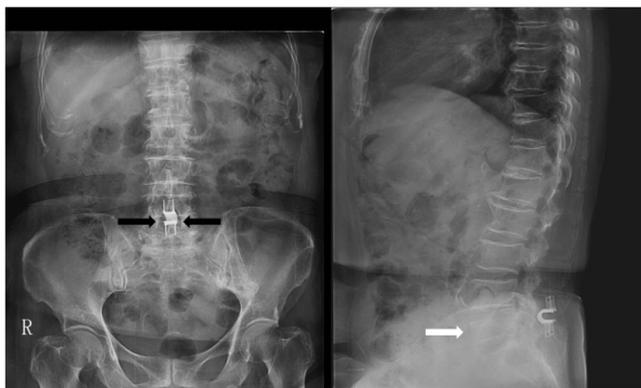
Figure 1. Plain radiographs show laminectomy (black arrow) with insertion of interspinous device at L4-5, but there are no definite abnormal findings except slight decrease of height of L5 vertebral body (white arrow).

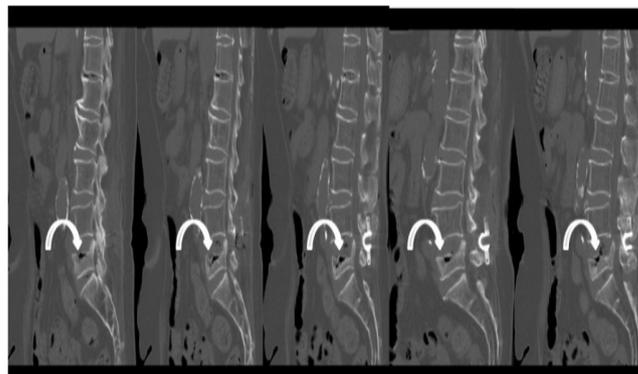
Figure 2. Consecutive sagittal CT scans show air bubbles within L5 vertebral body (white curved arrow).

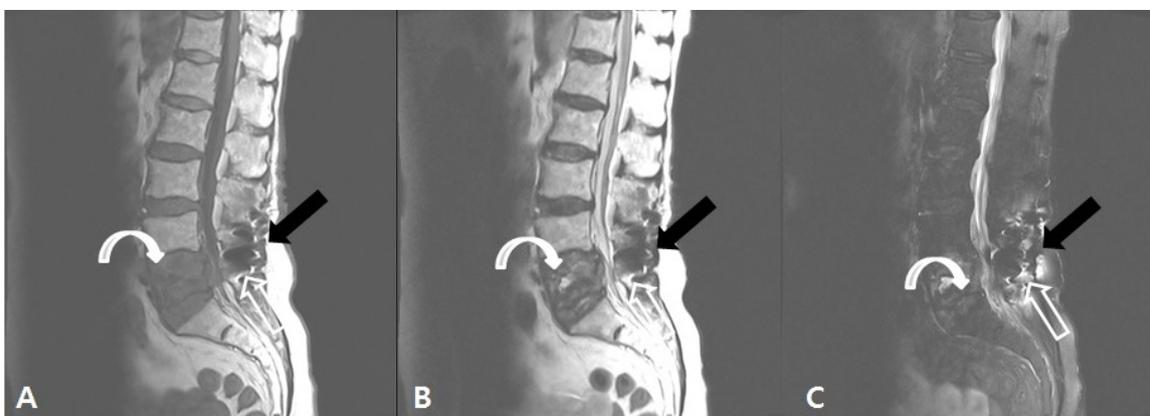
Figure 3. Sagittal T1-weighted (A), T2-weighted (B), and fat suppression T2-weighted (C) MRI. There is horizontally placed homogeneous dark signal suggesting intravertebral air within vertebral body on sagittal images (white curved arrow) and low signal showing metallic artifact (black arrow) and adjacent fluid collection around interspinous device (white arrows).

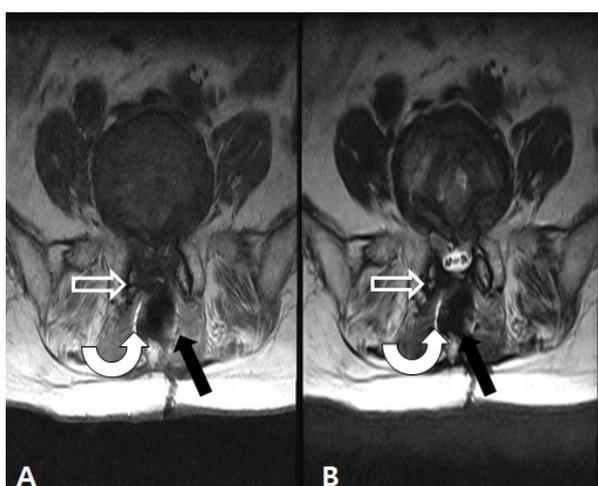
Figure 4. Axial T1-weighted (A) and T2-weighted (B) MRI. Transverse linear low signal (white arrows) suggesting right L4 inferior articular process is seen on axial T1- and T2-weighted images. Metallic artifact (black arrow) and fluid around device (white curved arrow) is also shown.

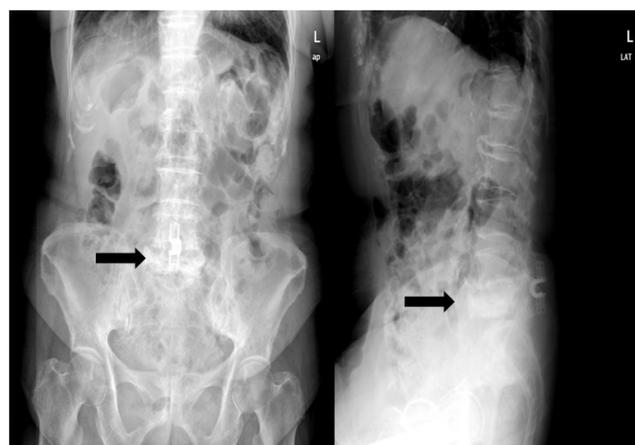
Figure 5. Plain radiographs show a collapse of L5 body after one year follow-up.
