## **New esthetic dental material: “autologous tooth crown transplantation”. A clinical report.**

### **Abstract**

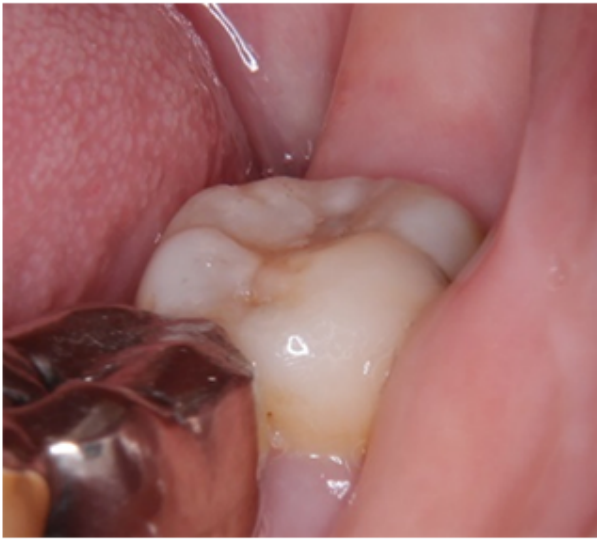
**Figure 1.** The third molar on the left side of the mandible intended for extraction.

A 50 y old woman presented in May 2016 with a mandibular left-side third molar that she wished to have extracted (Figure 1). Concurrently, the patient voiced concerns about the metal collar of a premolar. It was decided to extract the third molar because the tooth did not have an opposing tooth, and deterioration of the intra-oral environment was expected. The extracted tooth was used to fabricate an autologous tooth crown transplant to be used at the upper second premolar (Figure 2).

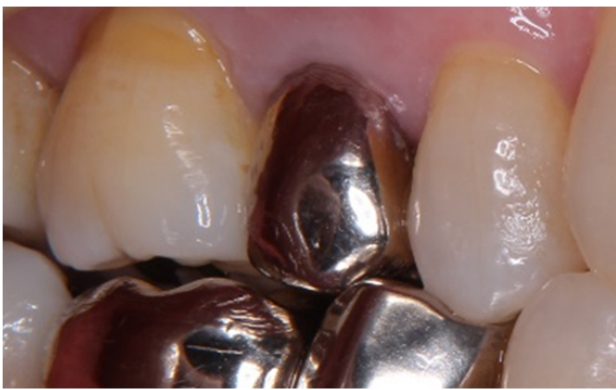
**Figure 2.** An autologous tooth crown transplant performed on the maxillary right-side second premolar.

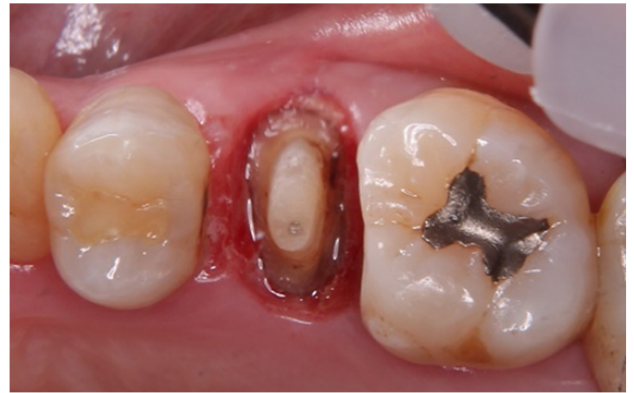
**Figure 3.** Completion of tooth preparation and abutment construction.

After the metal crown and resin core were removed from the premolar site and a fiber-reinforced resin core (Fiber Post N, GC, Tokyo, Japan; Clearfil DC Core Automix, Kuraray, Tokyo, Japan) was implanted, an abutment tooth formation was prepared with a round-shoulder finish line and an inverted roof-type occlusal surface configuration (Figure 3). Approximately 7 mm of clearance was secured. An impression of the die was made using polyvinyl siloxane impression materials (Exafine putty type, GC Corp, Tokyo, Japan; Tosicon Pastel Regular, Dentsply, Tokyo, Japan) and a two-step impression technique, thus creating a working model (Figure 4).

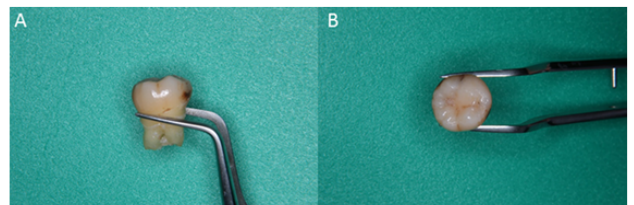
**Figure 5.** The left third molar of the lower jaw is extracted. A: Lateral surface. B: Occlusal surface.

The left third molar of the lower jaw was extracted and stored in physiological saline (Figure 5). The tooth root was then cut

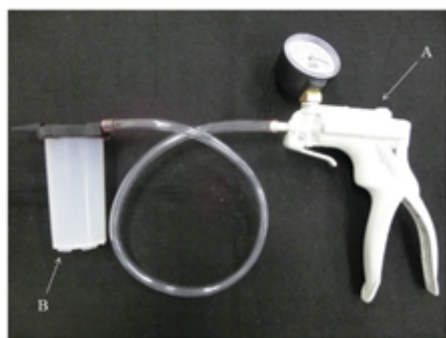
**Figure 7.** Vacuum hand pump (MV8000, Lincoln Industrial Corp. St. Louis, MO, USA). The hand pump is used to create a vacuum in the cup. A: Vacuum pump. B: Vacuum cup.

The vacuum pump used in the present study and a schematic diagram of the immersion device are shown in Figures 7 and 8,

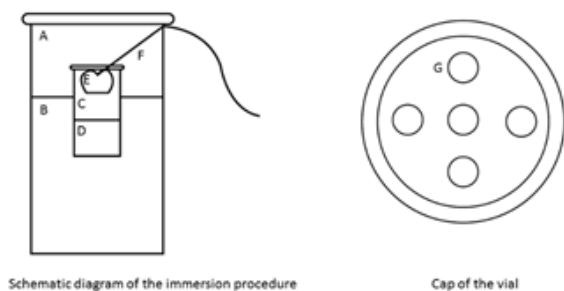
**Figure 8.** A: Vacuum cup, B: alginate impression material, C: vial, D: bonding resin, E: tooth crown, F: dental floss, G: air hole.

respectively. Air holes were created in the cap of the vial containing the bonding resin using a steel rod. Dental floss was fixed to the crown occlusal surface using a laboratory adhesive and passed through the air holes in the cap to prevent the tooth crown from making contact with the bonding resin. The vial was embedded in alginate impression material in a vacuum cup while pulling the dental floss to prevent the crown from being dipped into the bonding resin. The cap of the vacuum cup was then closed. The tooth crown was left for 1 min in a non-immersed state in the bonding resin under low vacuum conditions. The dental floss was then pulled from the vacuum cup and the tooth crown was immersed in bonding resin for 1 min. Normal atmospheric pressure was restored and the specimens were immersed for 5 min. The crowns were then removed and light curing was performed for 1 min. The immersion step used is illustrated in Figure 9.

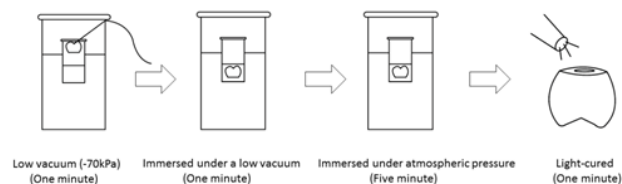
**Figure 9.** Immersion steps in resin bonding.

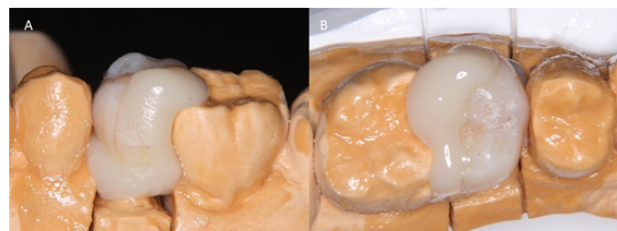
**Figure 10.** Fitting of the transplant crown with composite resin. A: Buccal surface. B: Occlusal surface.

Petroleum jelly was applied to the surface of the working model abutment. Thereafter, composite resin (Clearfil Majesty ES-2, Kuraray, Tokyo, Japan) was built-up on the inner surface, margin, and the distal surface of the transplant crown. The adjacent tooth and the marginal ridge were combined, and then light irradiated for 2 s, before the transplant crown was removed from the working model. Light-curing for 2 s and

detachment from the working model were repeated until the composite resin had cured (Figure 10).

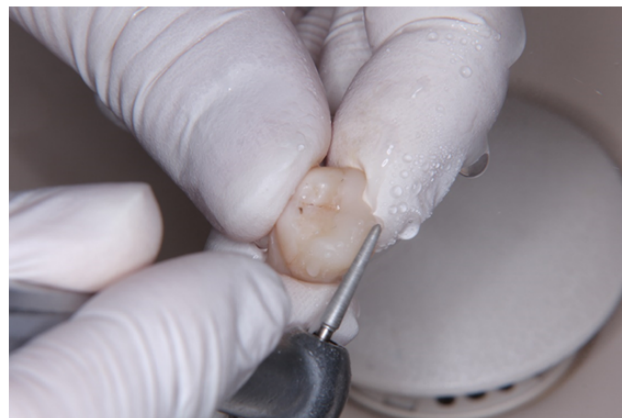
**Figure 11.** Modification of transplant crown morphology.

Excess resin was removed from the transplant crown using a high-speed diamond bur, and the shape was modified and caries were removed (Figure 11). The occlusion was adjusted to achieve slight contact, with maximum intercuspation and lateral movement. The complete transplant crown is shown in Figure 12.

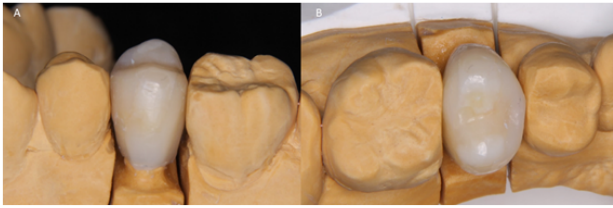
**Figure 12.** Completion of transplant crown. A: Buccal surface B: Occlusal surface.

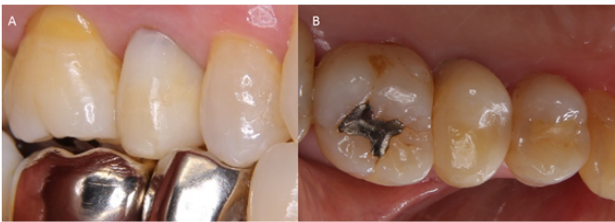
**Figure 13.** Transplanted crown after cementing. A: Buccal surface B: Occlusal surface.

Adjustment contacts and adjustment occlusion were performed before cementing, which was performed using Super-bond (Super-bond, Sun medical, Shiga, Japan). An intraoral photograph after cementing is shown in Figure 13. After cementing, the patient continued to exhibit a favorable outcome at the six-month follow-up evaluation (Figure 14).

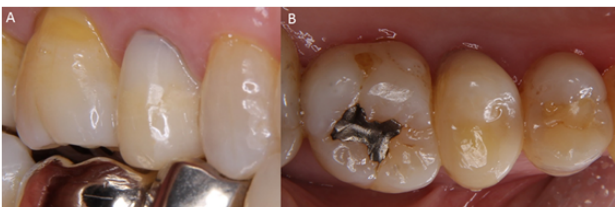
**Figure 14.** A and B: Six-month follow-up evaluation revealing stable clinical performance of the transplanted crown.
