# Volar plate fixation after distal radius fracture are as stable as a healed plated distal radius fracture.

## Abstract

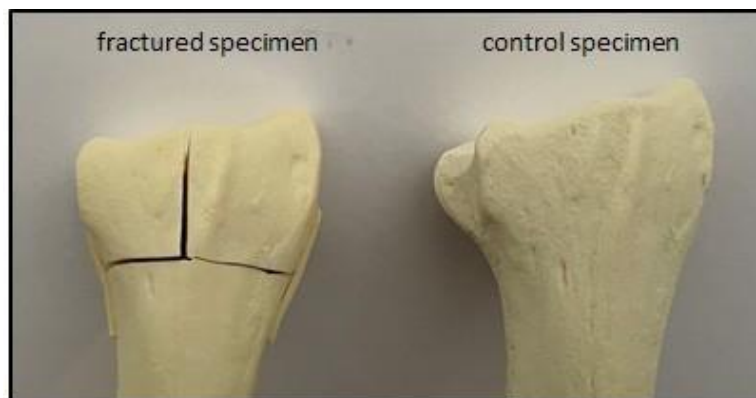
*Figure 1. Fractured specimen vs control specimen.*

Sawbone radii with white plastic cortical shell and foam cancellous core have been shown to mimic human cadaveric bone strength and therefore a good substitute model to utilize in testing [9,10]. Based on a previous biomechanical study of peak to load failure of volar plates, a power analysis of a suspected control mean of 400 +/- 110 with experimental group mean of about 200, an alpha equal to 0.05 and beta of 0.2, resulted in a sample size for each group of 5. Five fractured distal radii (fracture group) were compared to five intact distal radii (control group). A standard unstable, intra-articular 3-part distal radius fracture was utilized for the fracture group, which was a fracture of the radial column,

intermediate column and shaft (Figure 1). A Synthes 2.4 mm Variable Angle LCP Distal Radius System plate was utilized, which included 7 distal locking 2.4 mm screw holes and 3 proximal shaft nonlocking 2.7 mm screw holes. Plates were implanted onto the sawbones in the standard bicortical fashion leaving no fracture gap, utilizing all 7 distal locking holes and all 3 proximal holes. Both groups were similar in every detail except the created fractures in the test group (fracture group).

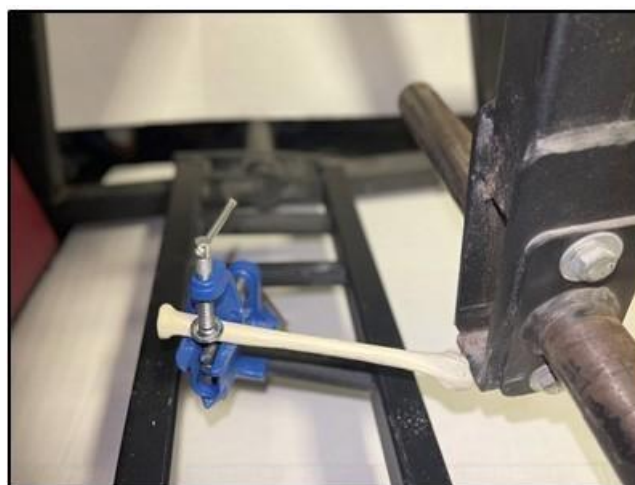
*Figure 2. Radius was placed into a clamp holding the proximal radius and at 80 degrees of inclination to the point of impact of the force vector. A swingarm with a weight on the end was employed to simulate the rotational fall onto an outstretched hand.*

The average fall onto an outstretched hand is about the height of the elbow falling rotationally, and the average height of the elbow is about 41 inches with average wrist extension during such a fall being 80 degrees [11,12]. Each distal radius was placed into a clamp holding the proximal radius and at 80 degrees of inclination to the point of impact of the force vector. A swingarm 41 inches long with a weight on the end was employed to simulate the rotational fall onto an outstretched hand (Figure 2). Weight was increased by 5 pounds until failure of fixation of the plate-sawbone construct. Failure was defined as the plate no longer providing fixation, that is, holding the bone fracture fragments of the distal radius together.

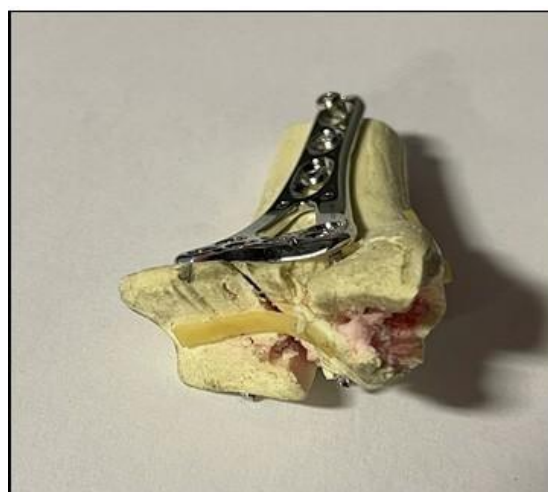
**Figure 3.** After peak to load failure resulting in a comminuted end of the plated distal radius in a control sample (unfractured group).

by sustaining increased comminution of the main fracture fragments and the constructs falling apart (Figure 3). There was no fracture proximal to the end of the distal radius in the plated shaft portion and no plate breakage in either group. The average force of failure in the control group was 150 N (range 117 – 211 N) compared to 145 N (range 117 – 211 N) in the fractured group. The differences were not significant (Table 2).

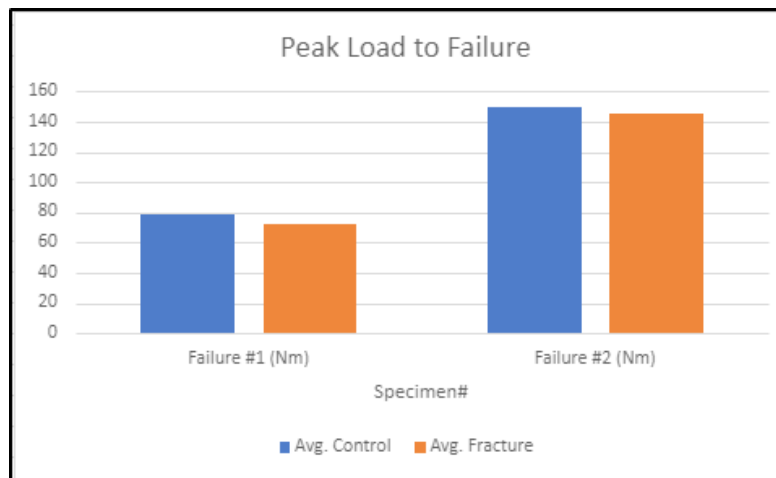
**Figure 4.** Comparison of the two peak load to failure results.

and with a rotational vector of force. Sobky et al created a sawbone plate construct with a wedge of metaphysis excised so that the force would be focused on the plate itself. In that study, the Synthes plate failed just below 400 N. Therefore we expected the failure point to be below that level (Figure 4). Demonstrates the results of our testing. Both control group and fractured group initially failed by sustaining a fracture proximal to the plate. This empirically makes sense as the stiffness of distal radius plates are higher than that of bone and protective of the bone underneath. This effect is also observed in practice with individuals who have a distal radius plate in place and sustain a fall. Additionally, this may also result from stress shielding and subsequent weakening of bone at the area just proximal to the plate in vivo.
